HARN, BUA SI

Diawi
	Title	Part Number P-BUA-SILVERADO_		Eng A
				Mfg A
	Description 2020 Chevrolet Silverado Backup Alarm Harness		Revision	QA

Wiring Harness for Backup Alarm 2016-2021 Chevrolet Silverado

**INSTALLATION MANUAL**

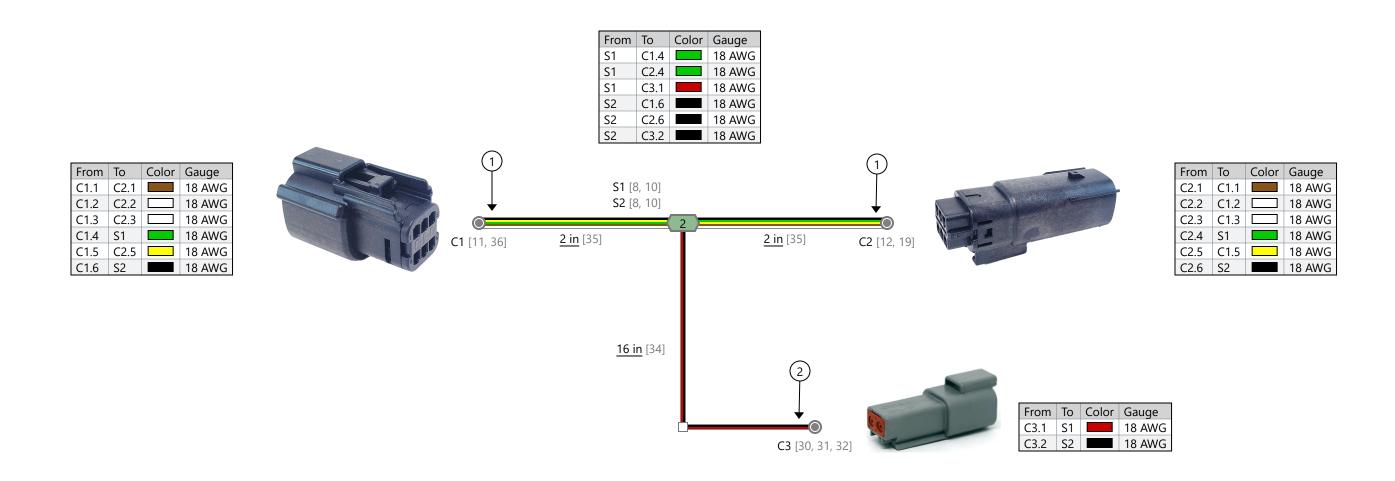
ı	Notes				
ı	1) Cover wiring with cloth tape; leave 1/2" of exposed wiring behind connector				
ı	2 Lock tape split loom behind C3

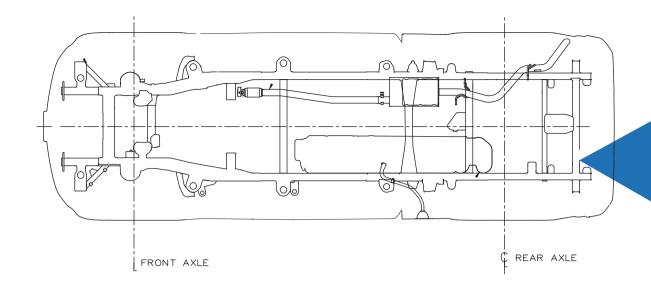
OEM tail lamp connector is inside driver side frame rail above spare tire

Locate the OEM tail lamp connector that is below the truck

- The connector is to the left of the vehicle's spare tire on the cross member

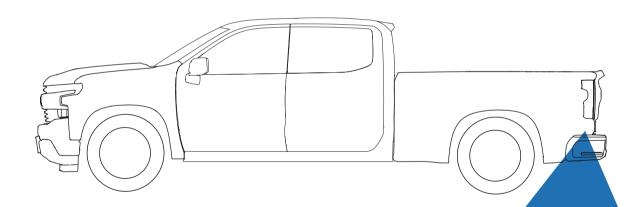
Backup alarm is located on the street side of the driver side frame rail; below the driver side tail lamp cavity

Use an impact drill and 10mm nut-setter to install a compatible backup alarm on the metal surface that is below the truck's tail lamp cavity (just outside and above the driver side frame rail).
